Manhole Inspection Summary

Manhole # S53Q__006MH

Inspection ☐ Is Incomplete Rating: **3) Fair**

Insp Date: **9/23/08 9:55 AM**

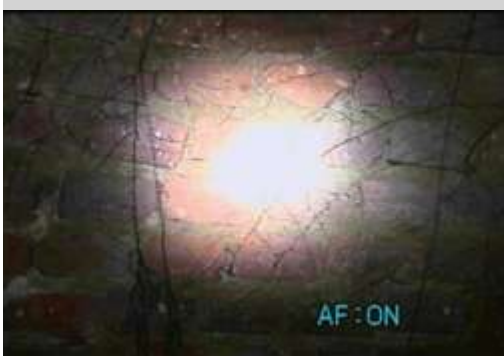
Defect 3

Condition: ☐ Sound ☐ Cracked ☒ **Root Intrusion** ☐ Loose Brick ☐ Deteriorated

root intrusion in barrel

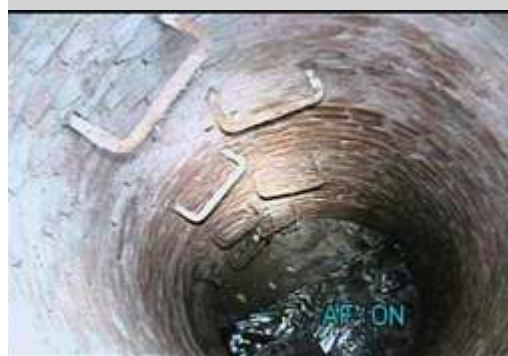
Defect 2

Count: **7** Missing: **0** ☒ **Corroded**

corr steps

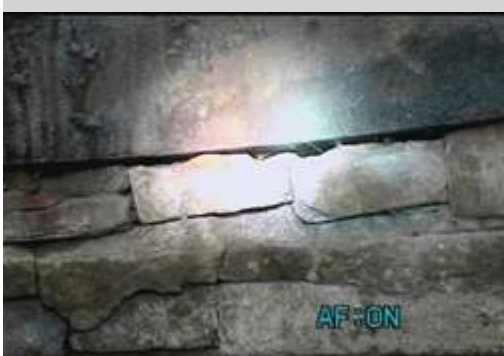
Defect 1

Condition: ☐ Sound ☒ **Cracked** ☐ Root Intrusion ☒ **Loose Brick** ☐ Deteriorated

chimney loose bricks, cracked, frame adj

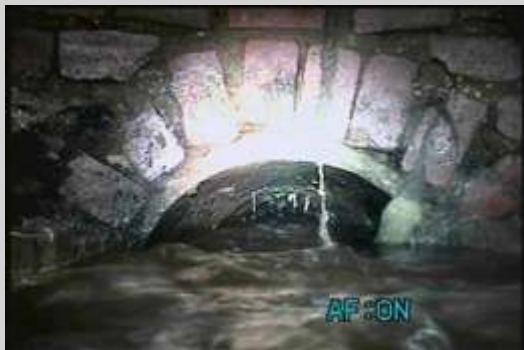
12 O'Clock Outflow

12 in. Circular Gravity Sewer
Pipe Out @ 12 O'Clock

Pipe Material: **Clay** ☐ Pipe Lined

Invert Depth: **12.58** (ft.) Flow Characteristics: **Fast**

Deposits: ☒ None ☐ Mud ☐ Sludge ☐ Debris ☐ Grease

Infiltration: **None** Pipe Seal Cond: **Unknown**

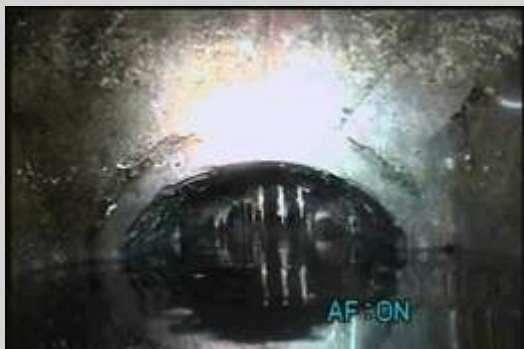
3 O'Clock Inflow

10 in. Circular Gravity Sewer
Pipe In @ 3 O'Clock

Pipe Material: **Clay** ☐ Pipe Lined

Invert Depth: **12.50** (ft.) Flow Characteristics: **Fast**

Deposits: ☒ None ☐ Mud ☐ Sludge ☐ Debris ☐ Grease

Infiltration: **None** Pipe Seal Cond: **Unknown**

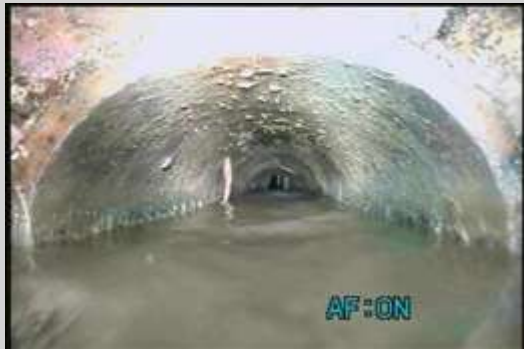
6 O'Clock Inflow

10 in. Circular Gravity Sewer
Pipe In @ 6 O'Clock

Pipe Material: **Clay** ☐ Pipe Lined

Invert Depth: **12.46** (ft.) Flow Characteristics: **Fast**

Deposits: ☒ None ☐ Mud ☐ Sludge ☐ Debris ☐ Grease

Infiltration: **None** Pipe Seal Cond: **Unknown**
